*This is an inspection report and a cost estimate to rebuild the rear structure located at XXXXXXXXXX, Plainville CT 06062*

### **Inspection Report:**

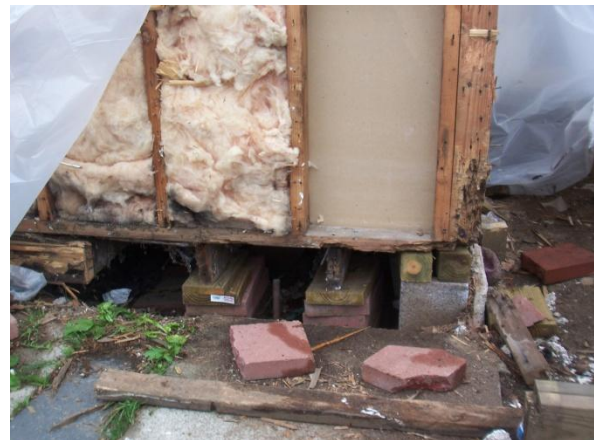
The rear structure to the property listed above is currently being used as a mechanical (utility) and Laundry Room. Proceeding forward in this inspection report the rear structure will be labeled as: UTILITY ROOM. The utility room is in serious violation of several major building codes. The structure is sitting on cinderblocks placed on the ground under the structure. State building code requires that any structure connected to a house will be set on a concrete foundation, pier, or footing at least 42" below grade.

- Remove all utility equipment including furnace, laundry, water heater, and ductwork; disconnect all electrical, plumbing and fuel lines.
- Demolish entire structure.
- Pour new foundation (to be same size as existing structure).
- Install new insulation, sheetrock and carpet flooring.
- Re-build the structure and reinstall all utility equipment.
- Roofing and siding to match existing
- Demolition included
- Dumpster included
- 10 year warranty included
- Permit fee included
- Plans included

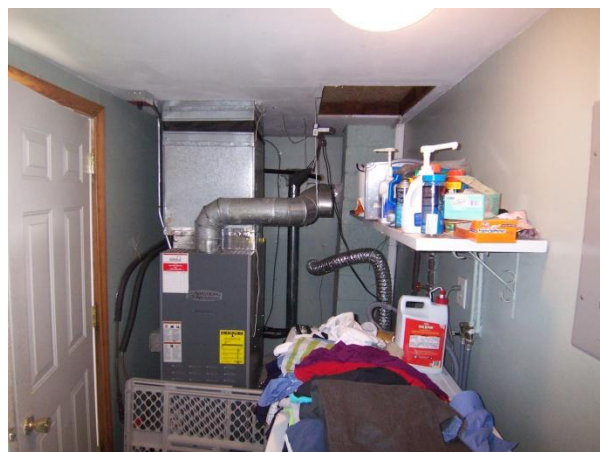
Because the utility room is not sitting on any type of code required foundation it is sinking into the ground. There is mechanical equipment including a furnace and water heater in the utility room. As the structure begins to pull away from the main house it is possible that mechanical fuel lines can be severed and create a fuel leak potentially leading to a fire.

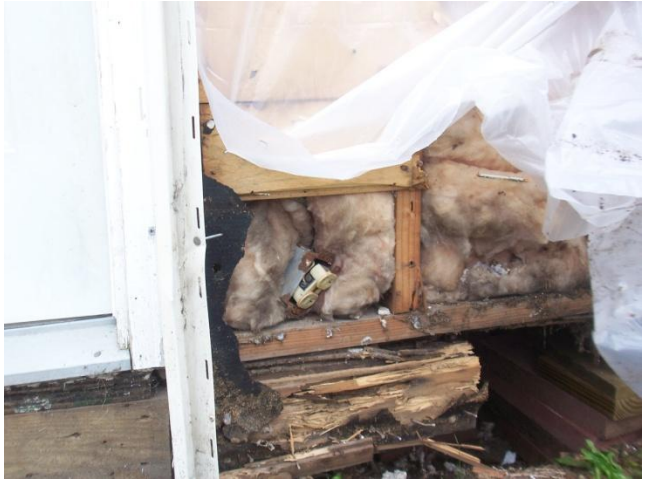
The utility room's framing is not acceptable by Code, there appears to be no structural beam under the utility room, the framing members are inadequate to support the live load in the utility room. There is also major water damage to the floor framing. The floor framing appears to be constructed of typical Douglas fir framing material which is not rated for outdoor/ high moisture areas. By code, the floor framing system should be framed using pressure treated lumber.

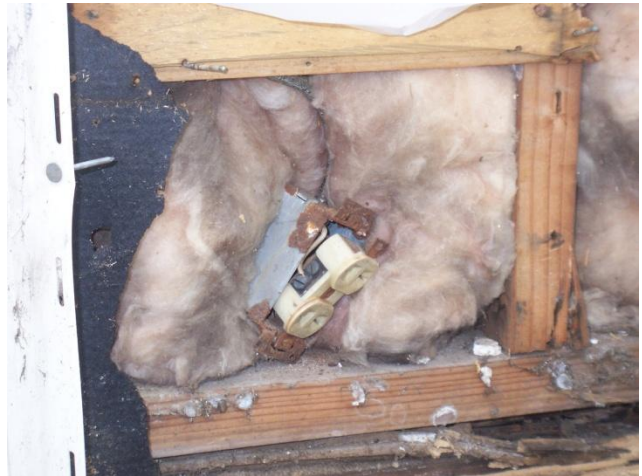
Upon inspecting the interior wall cavities evidence of mold and rot can be seen. There are also major electrical violations within the utility room. Upon investigating the wall cavities a hidden electrical outlet had been uncovered, this electrical outlet is buried in a wall cavity. The outlet appears to be connected to the main breaker panel. The area where the electrical outlet is buried is the same area where there is strong evidence major water intrusion. A live outlet buried in a wall where there is water leakage poses a serious fire hazard.
