*This is an inspection report and a cost estimate to rebuild the rear structure located at XXXXXXXXXX, Plainville CT 06062*

### **Inspection Report:**

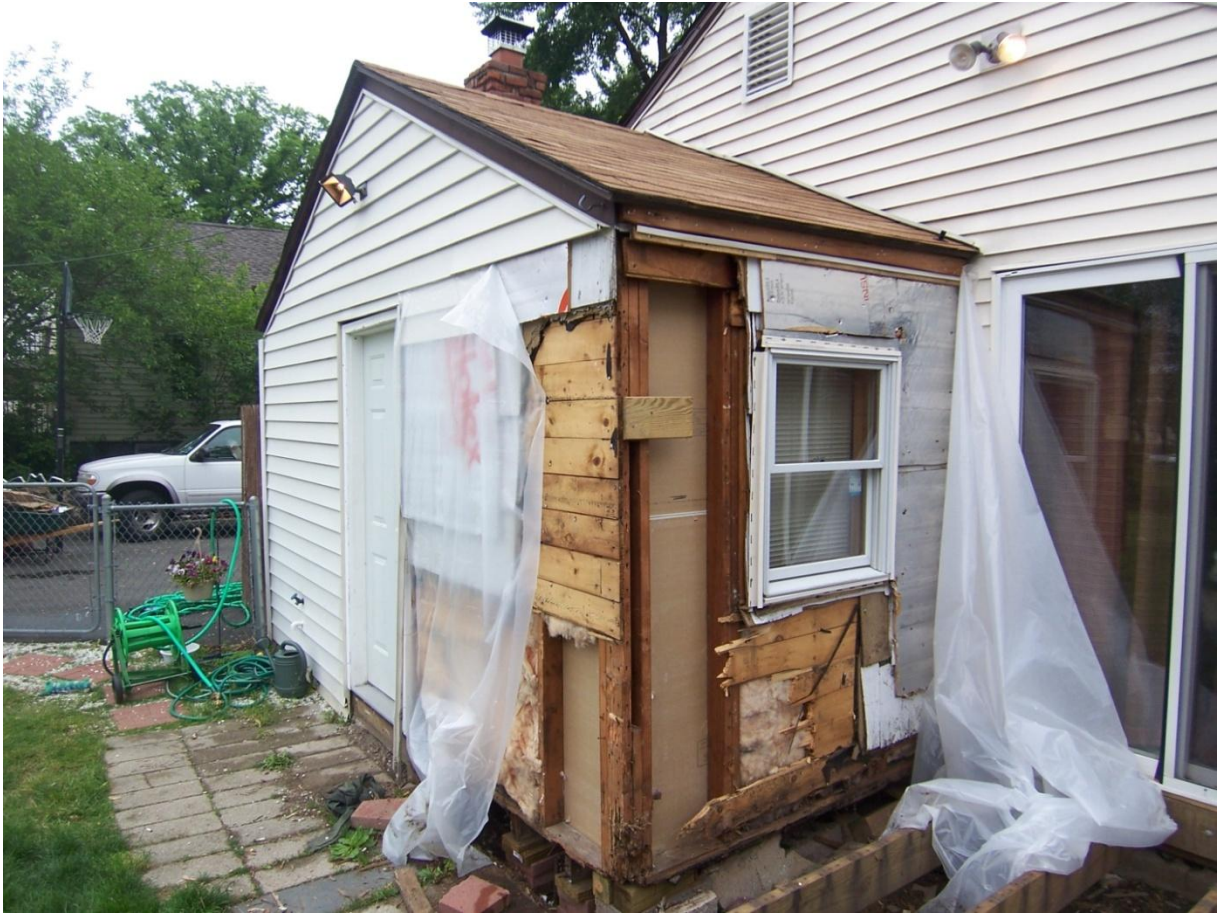
It is our opinion that this project was built without a permit from the building department from the town of Plainville CT, there is no way possible that a building inspector would have approved the construction, methods used, and materials used for the utility room. This utility room poses several health and fire hazards and should be torn down and rebuilt.

- Remove all utility equipment including furnace, laundry, water heater, and ductwork; disconnect all electrical, plumbing and fuel lines.
- Demolish entire structure.
- Pour new foundation (to be same size as existing structure).
- Install new insulation, sheetrock and carpet flooring.
- Re-build the structure and reinstall all utility equipment.
- Roofing and siding to match existing
- Demolition included
- Dumpster included
- 10 year warranty included
- Permit fee included
- Plans included
